SERVICE BULLETIN

Date: July 10, 2018
Update Number: S2018-02
Subject: Trolley Service Kit K75-39337
Product Affected: LiftMaster® Models LA500DC, LA500DCS

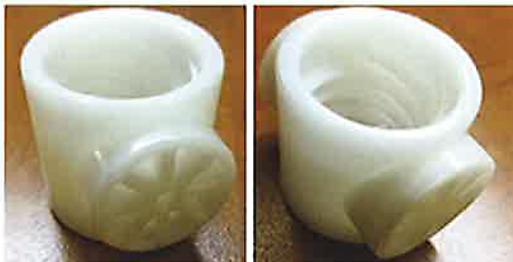
The travel nut on LA500DC and LA500DCS gate operators may break when excessive force is applied to the gate, such as being struck from a vehicle. The travel nut can be identified as the white plastic nut that attaches to the internal lead screw of the arm. The symptom of this problem is that the trolley assembly slides back and forth along the guide slots without mechanical restraint. The broken part can be observed through the guide slots on the bottom of the arm.

LiftMaster has created Trolley Service Kit K75-39337 with all the necessary parts and provides instructions on how to replace a damaged travel nut within an LA500 arm. LiftMaster advises the travel nut replacement to be conducted in a controlled environment such as on a bench in a workshop, due to its complexity and the opportunity of dirt/debris being trapped within the transmission of the arm.
