**Date:** September 25, 2026  
**Update Number:** P2026-17  
**Subject:** LA400 and LA412 Actuator Arm Resolution  
**Product Affected:** See table below for specific models and affected date codes

Following-up Product Bulletin P2026-16 issued on 9/21/2026 (refer to FAQ's section for a reference), LiftMaster has identified a resolution outlined in the document below. This would address the unexpected error code 32 or 33 observed with LA400 and LA412 actuator arms after install on the subset of units within the date codes listed below.

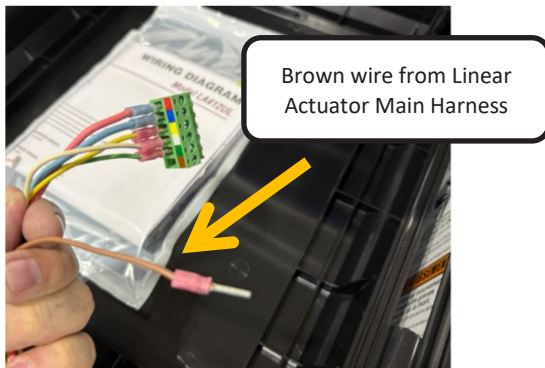
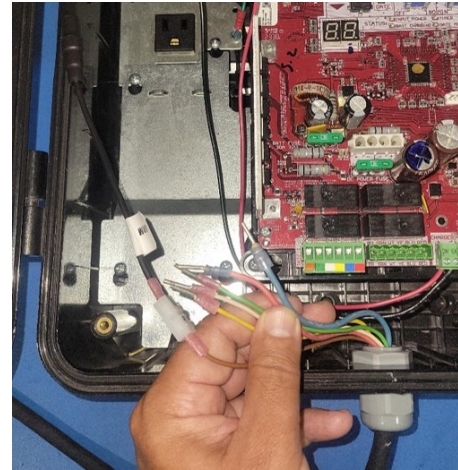
**FIGURE 1** - Remove the brown connector from the main linear actuator arm connector affected units

- Confirm that the unit is within the impacted window (**See FAQ**).
- Disconnect power from the operator.
- Remove the cable connector from the control board
- Remove the brown wire from the connector (**FIGURE 1**)
- Take the brown wire from the main linear actuator arm harness and insert it into the connector on the LA400/LA412 Wire Harness Jumper Kit harness (**FIGURE 2**). Note that the field wire harness has two labels – “BR” is on the connector end to connect the brown wire from linear actuator main wire harness. The “BOARD” label is on end to connect to main control board connector actuator input.
- Tighten the screw on the connector and gently tug the connection to confirm it is secure.
- Insert the opposite end of the LA400/LA412 Wire Harness Jumper Kit into the brown wire position on the connector.
- Tighten the connector's screw terminal to secure the wire.

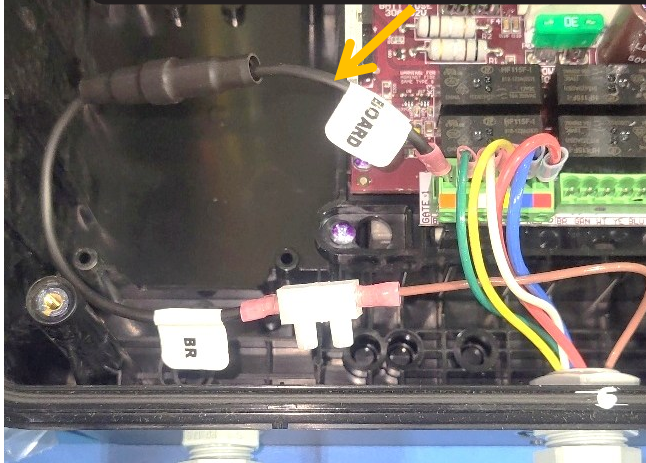
**FIGURE 2** - Connect the brown wire to the LA400/LA412 Wire Harness Jumper connector and tighten screw. The label "ARM" is the end that connects to Linear Actuator Main Wire Harness

LA400/LA412 Wire Harness Jumper with label "Board" is connected to Actuator Arm Harness

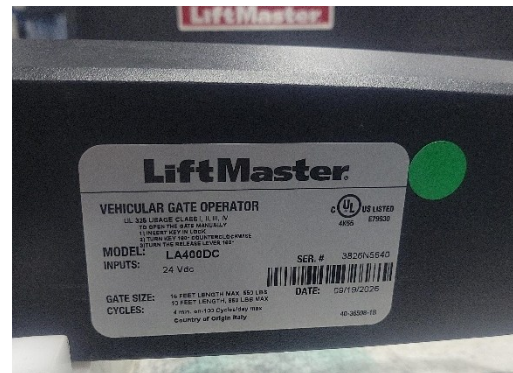
**FIGURE 3** Reconnect the main Actuator harness to the main control board

9. Reattach the connector to the control board. (**FIGURE 3**)
10. Restore power to the operator.
11. Reset the limits and test the unit.
12. Add the supplied green label to the operator, next to the UL label on the arm. This identifies that this operator has been updated. (**FIGURE 4**)

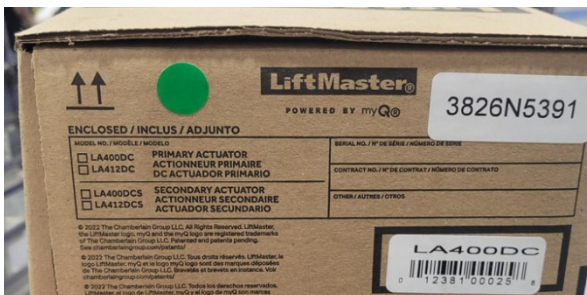
**FIGURE 5** – Green dot on the packaging representing a packed-in LA400/LA412 Wire Harness Jumper Kit (P/N 004-0078-000),

LiftMaster will pack the required LA400/LA412 Wire Harness Jumper Kit (P/N 004-0078-000), in the packages of the impacted product before shipping. These packages will be marked with a “Green Dot” sticker on the packaging for easy identification (**FIGURE 5**).

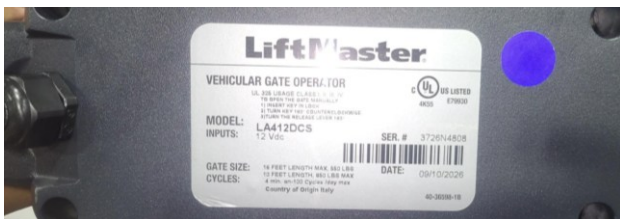
**FIGURE 6** – Blue dot next to UL label on Linear Actuator Arm on units not requiring the field fix

LiftMaster will apply a “Blue Dot” sticker to the packaging and to the bottom of the arm assembly next to the UL Label to easily identify these units for a period of 12 months (**FIGURE 6**). The Blue stickers are expected to phase out starting October 3rd, 2027 / Week 40 in 2027.
